A Conservation Study of
St. Paul's Methodist Episcopal Church
South
Randleman, North Carolina

prepared by
UNCG - Interior Architecture
Spring 2017
under the direction of
Professor Jo Ramsay Leimenstoll

Conditions Report

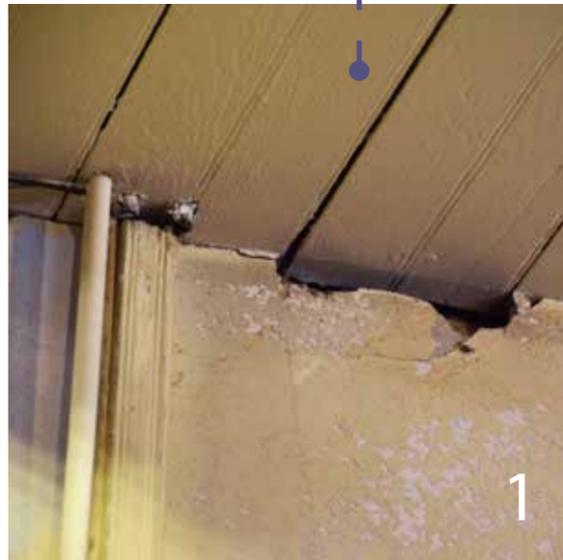
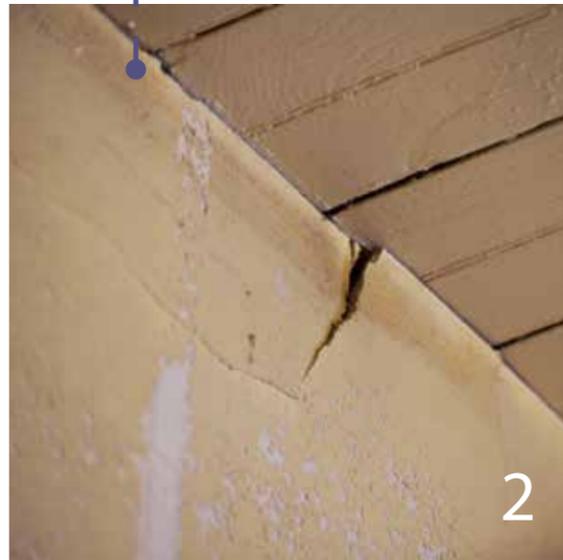
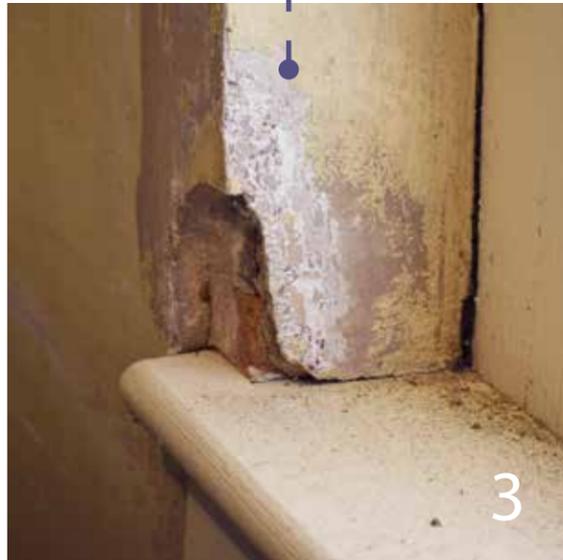
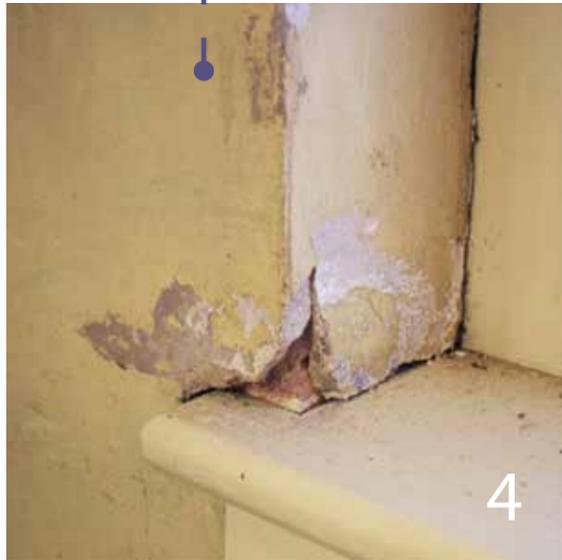
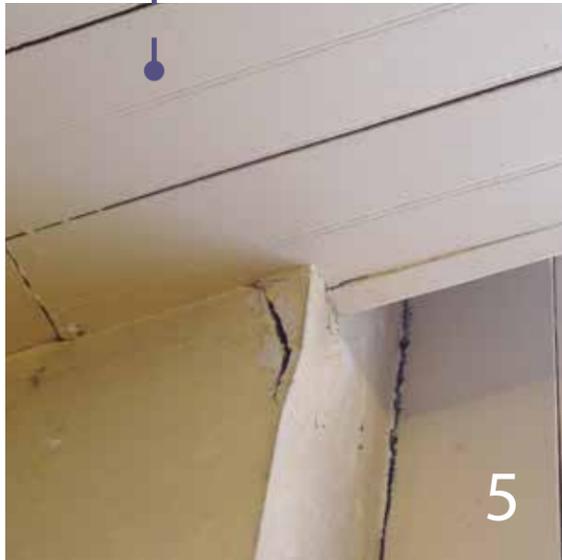
1-5. Cracks in plaster possibly caused by moisture.

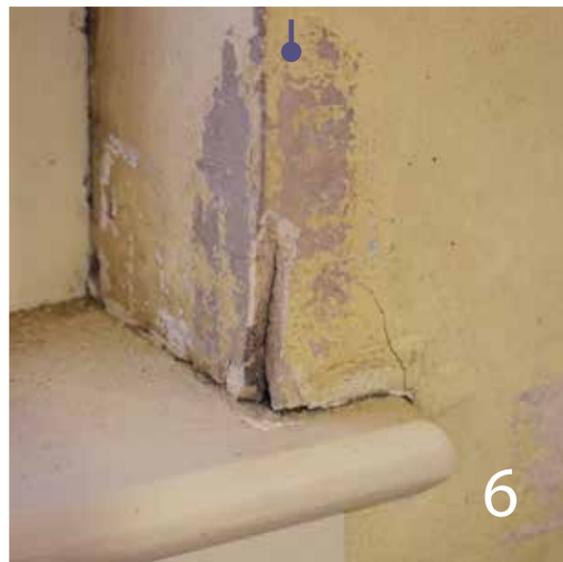
6

- 6. Moisture and lack of maintenance have caused cracks in plaster and peeling paint.
- 7. Moisture damage, on the north wall coming from the balcony, has caused discoloration on the wall, and separation of the ceiling/flooring.
- 8. The floor is beginning to deflect around the column, possibly due to improper support around the column that supports the second floor balcony.
- 9. Cracks in plaster below the window sill may be caused by the expanding and contracting of the wood.
- 10. The plaster has detached completely, exposing the brick wall behind it.

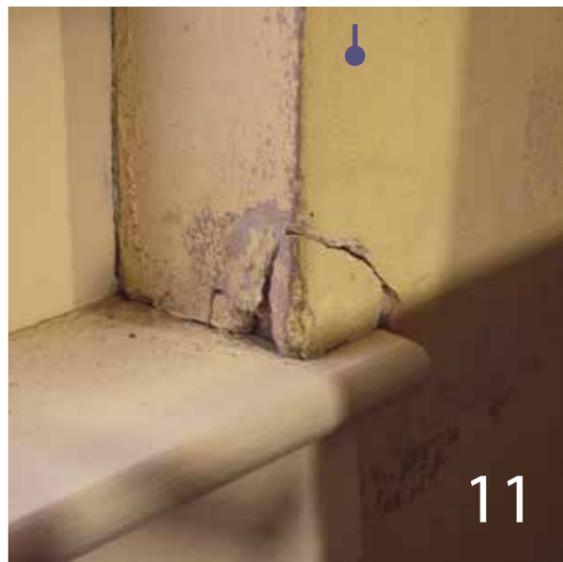
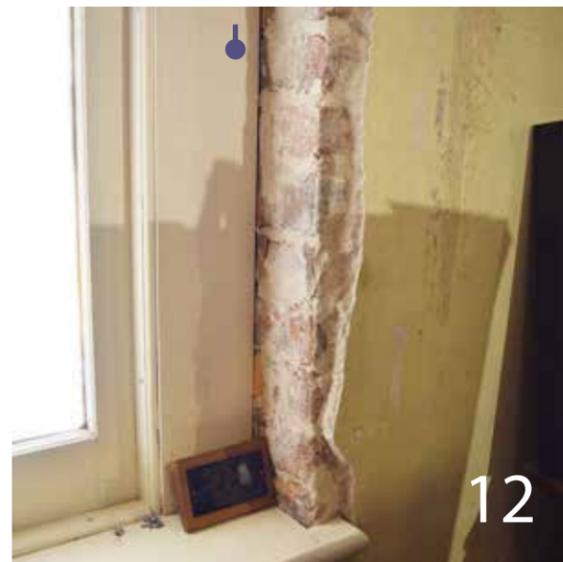
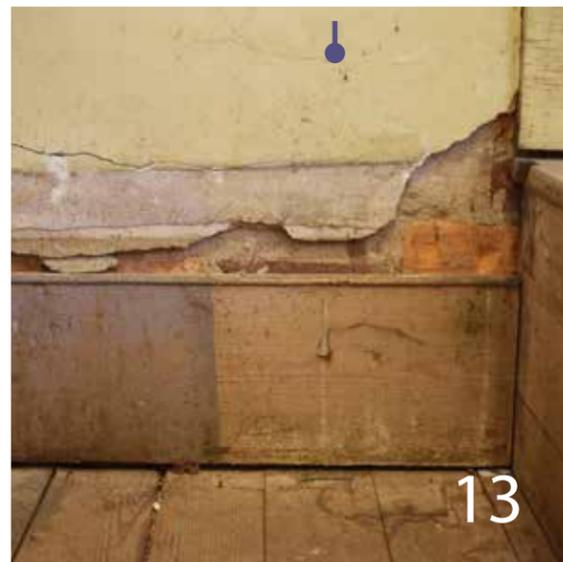
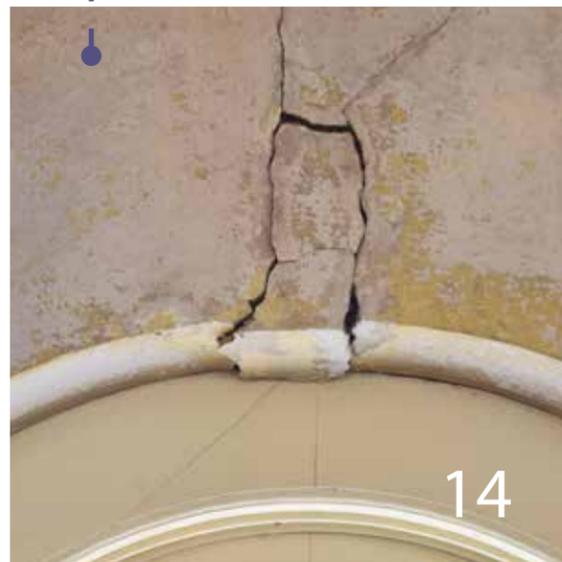
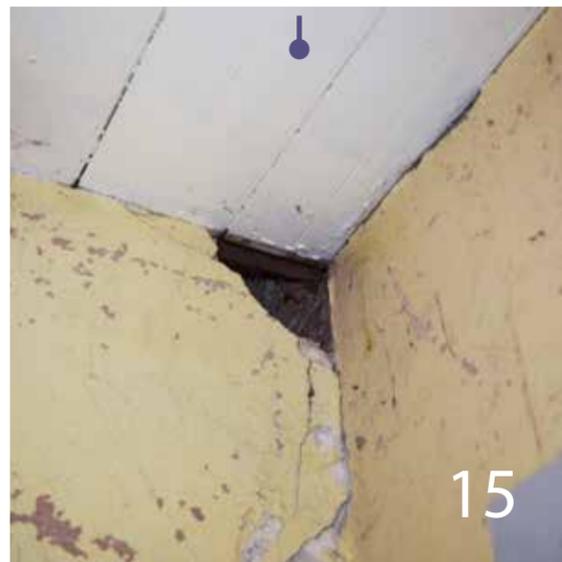
- 11-13. Cracks in plaster have various causes: lack of maintenance, the building settling, and additional weight on non-load bearing walls, causing stress on the material. In most cases, this has exposed the brick substructure.
- 14. The cracks in the plaster were caused by structural issues that have caused the keystone piece above the window to fail.
- 15. Excessive weight on the floor/ceiling has caused the plaster to detach completely.

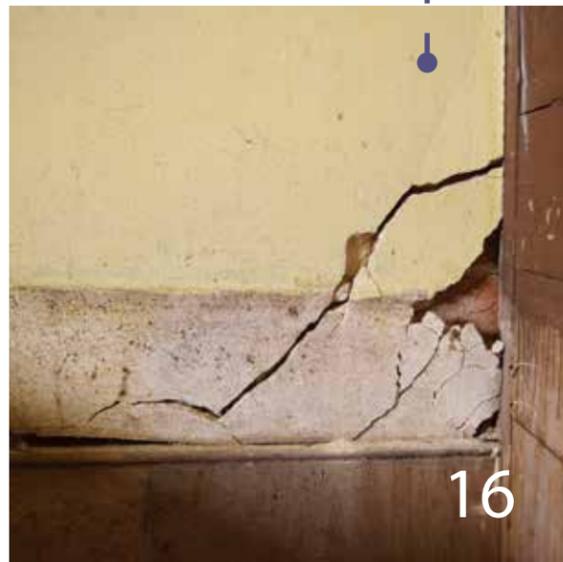
16

- 16. Cracks in plaster have caused it to separate from the brick.
- 17. Spalling bricks and deteriorated mortar joints caused by lack of maintenance, and/or additional weight on a non-load bearing wall.
- 18. Cracks in plaster caused by the building settling or additional weight on a non-load bearing wall.
- 19. Plaster repairs have caused water to infiltrate through the joints, causing discoloration on the wall beneath it.
- 20. Water infiltration from the ceiling, from earlier roof damage (now repaired), has caused discoloration on the wall.

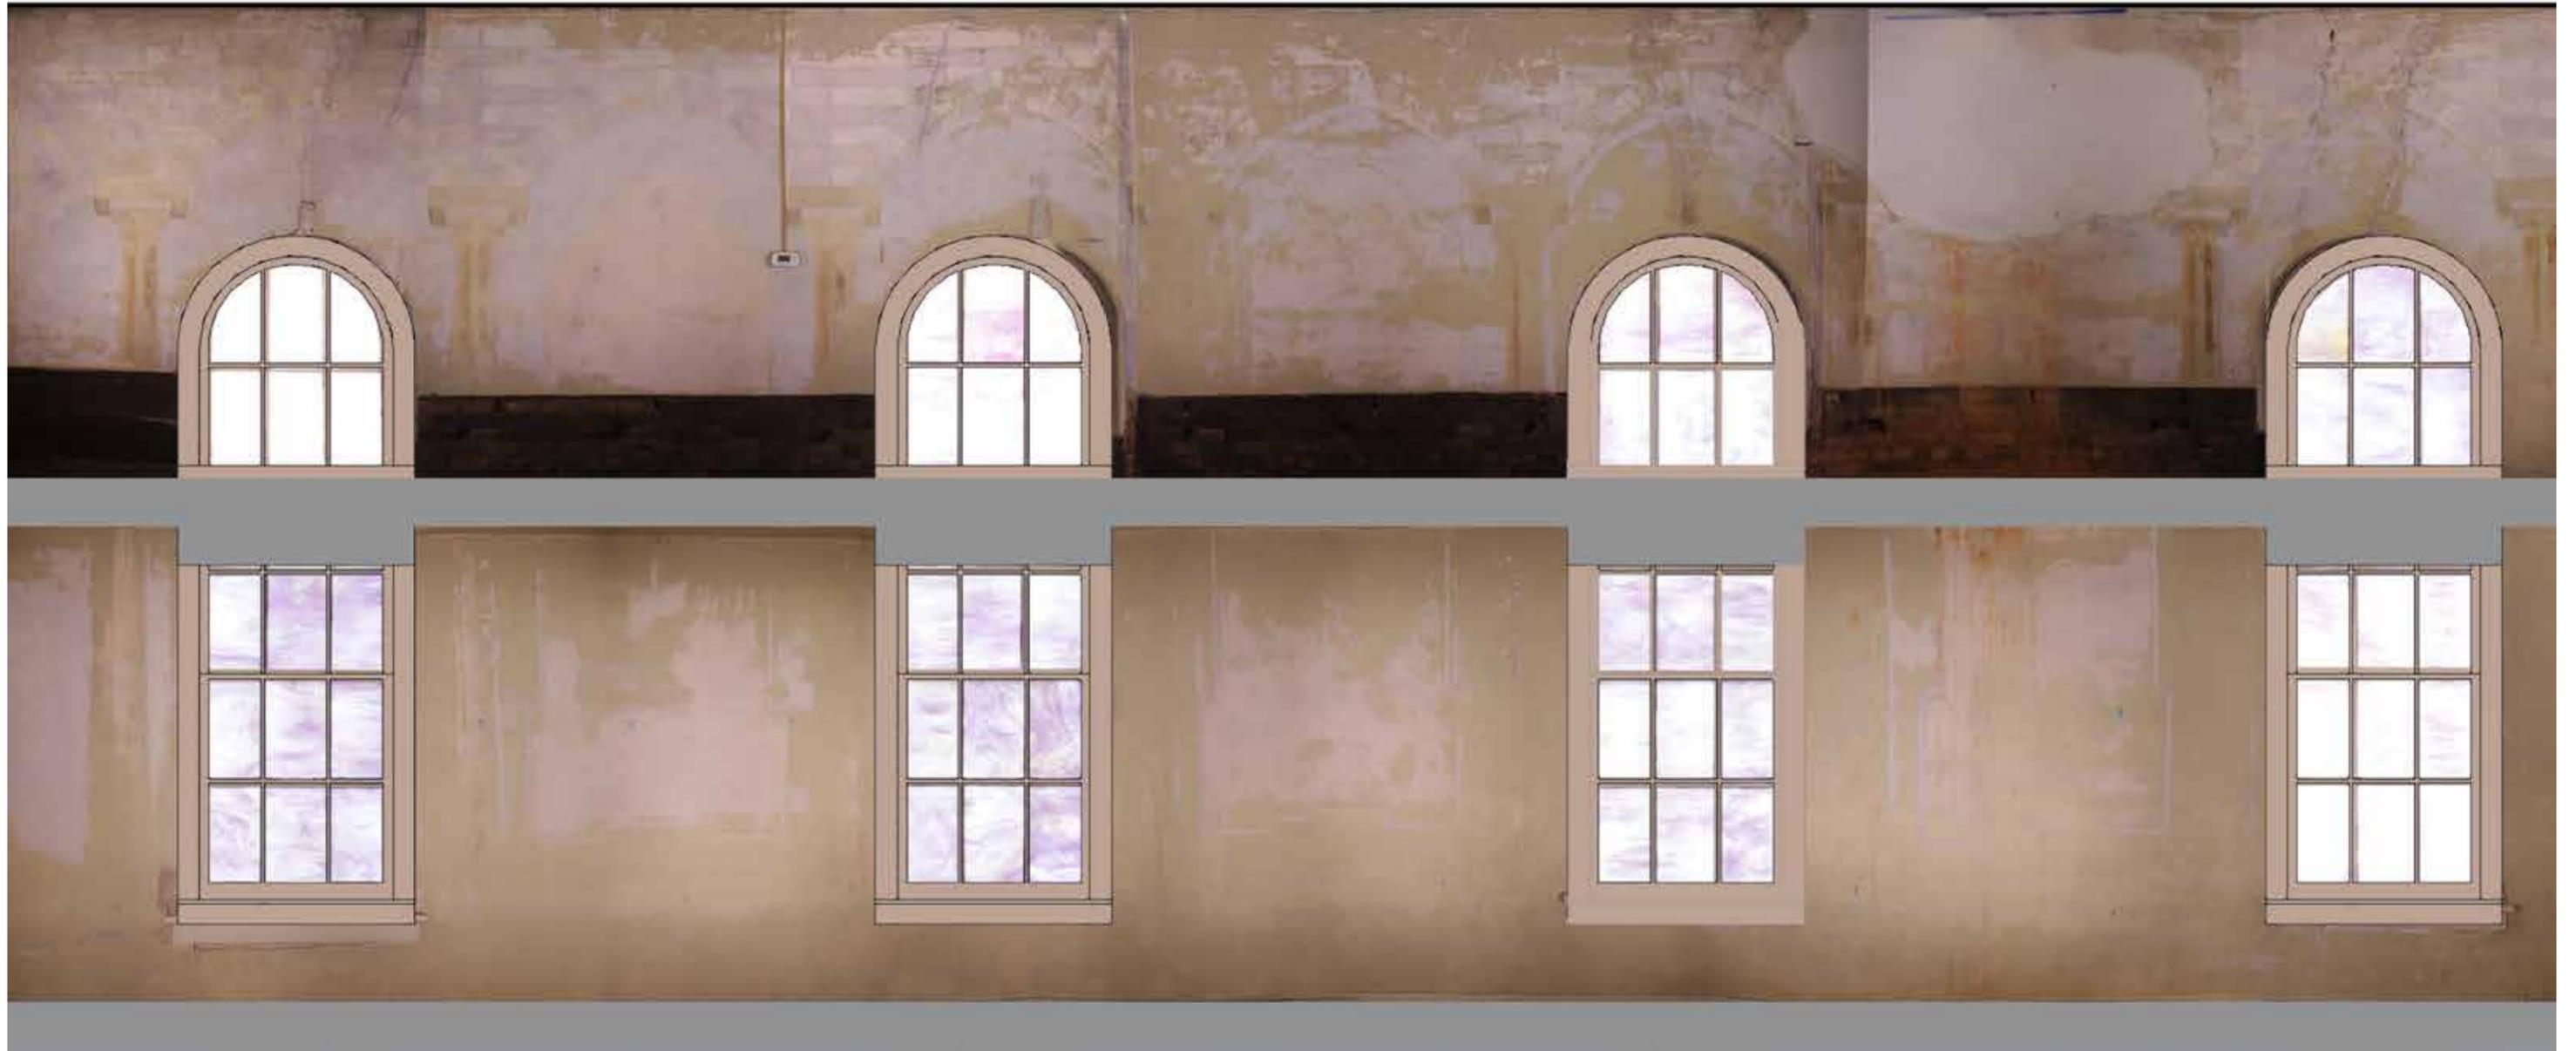
Current Condition of the Trompe l'Oeil on North Wall

As the National Register states, St. Paul's most unusual decorative interior painting is the trompe l'oeil Gothic arcade that was later painted over. Currently, most of it is difficult to see, however on the balcony level North Wall, we are able to see "stone-block-painted walls with lancet arches, tone fluted columns with lobed capitals, and shaped panels." The arches alternately frame the church windows and although the paint is mostly washed out, there are areas that still show the original, darker grays of the stones and the dark red mortar joints.
