A Conservation Study of
St. Paul's Methodist Episcopal Church
South
Randleman, North Carolina

prepared by
UNCG - Interior Architecture
Spring 2017
under the direction of
Professor Jo Ramsay Leimenstoll

Conditions Report

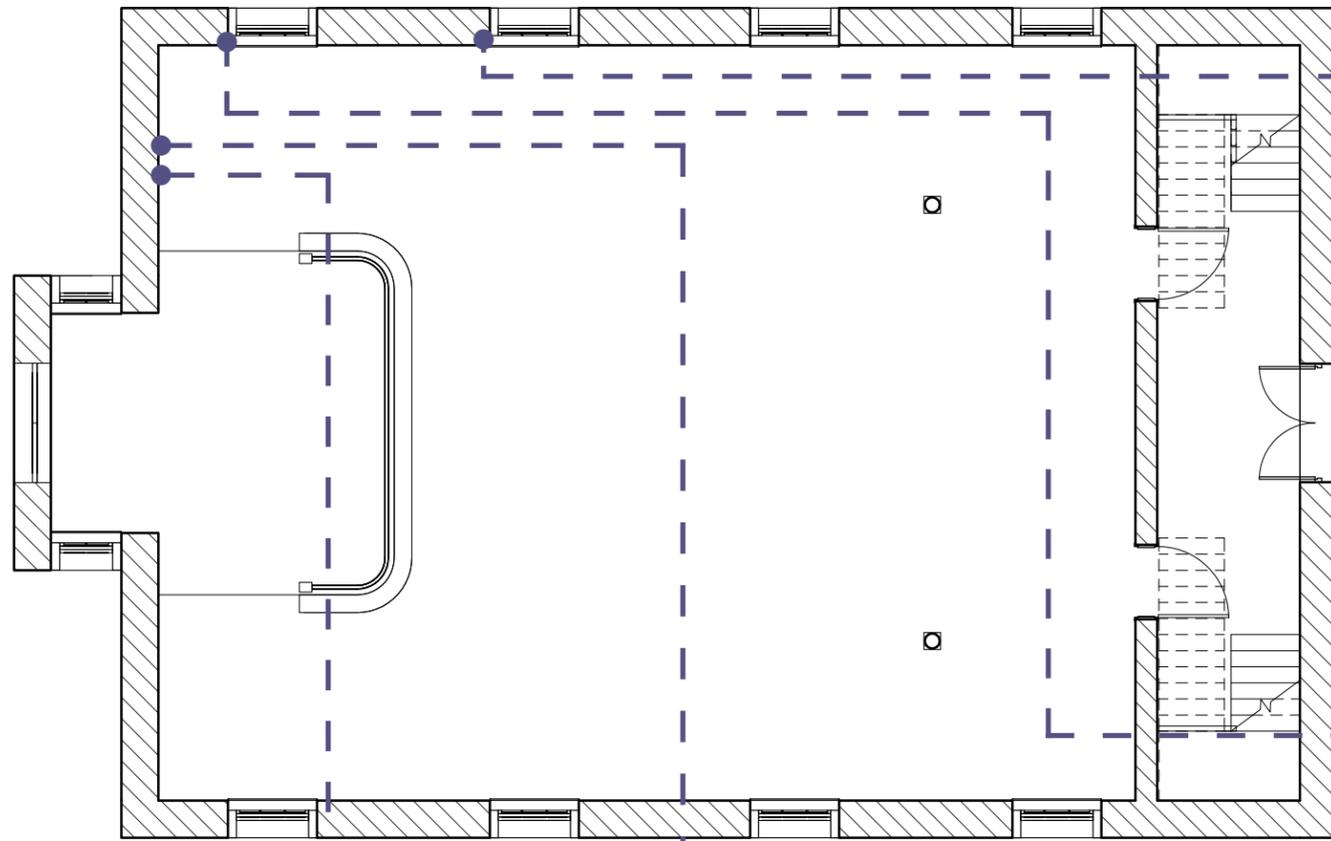
West and North Wall and Ceiling Conditions

The overall deterioration of the interior of St. Paul's Church is minimal, and is mostly caused by weathering and natural causes, due to lack of maintenance for an extended period of time. This has caused moisture to infiltrate the building, and cause damage to the plaster and paint on the walls and windows. Additionally, the building may have suffered from excessive weight on non-load bearing walls, contributing to the deterioration.

1-5. Cracks in plaster possibly caused by moisture.

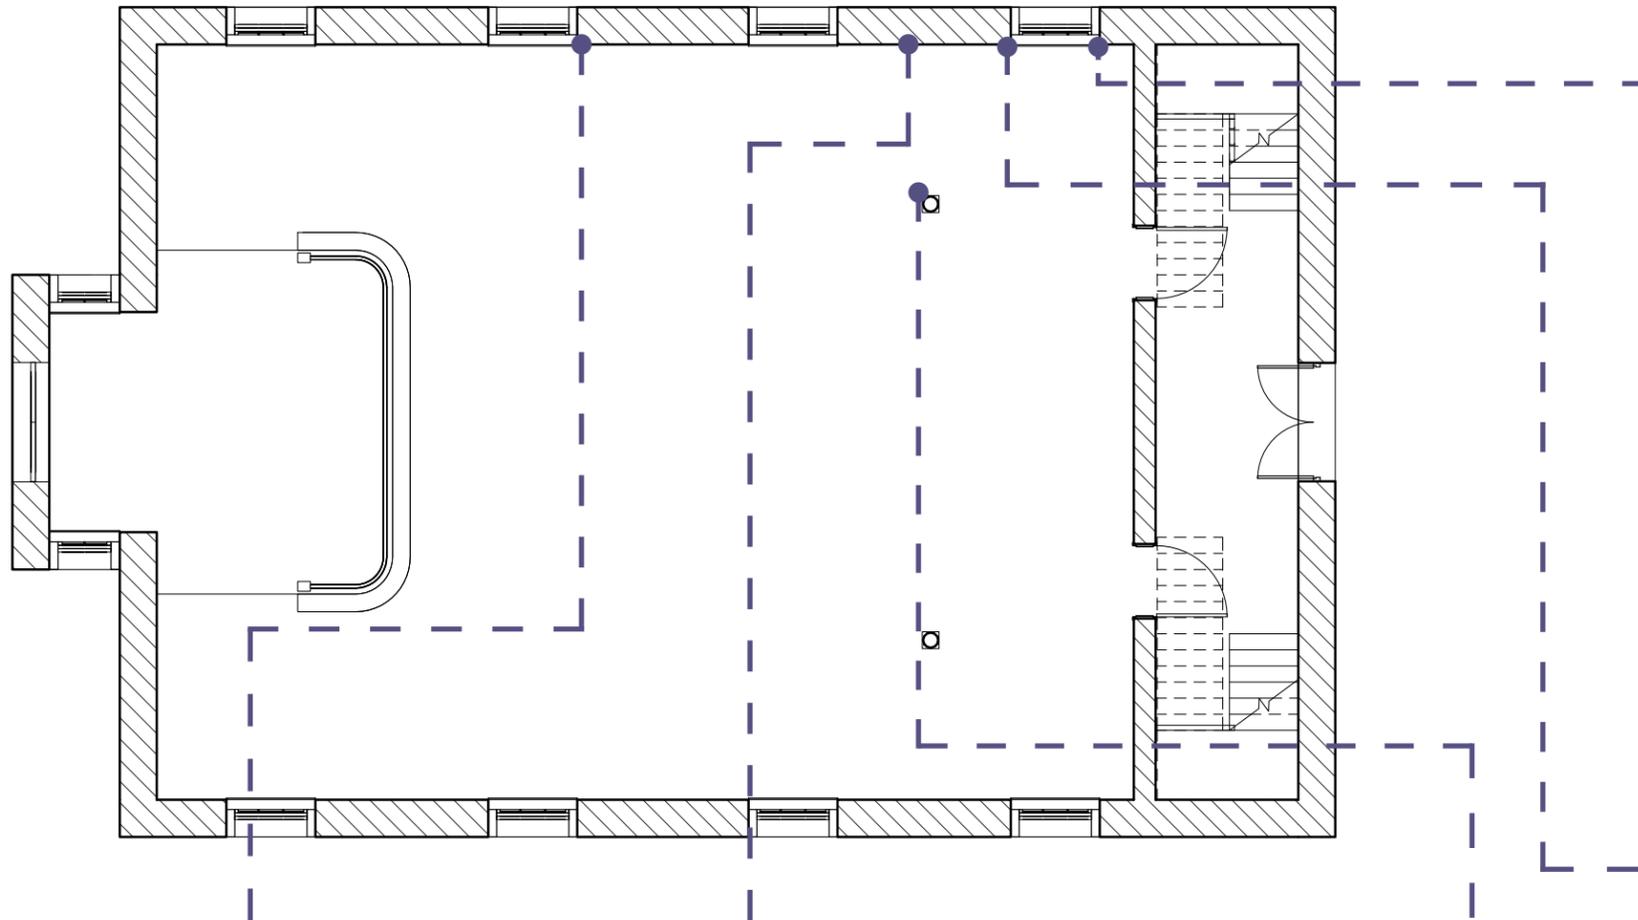
North Wall, Ceiling, and Floor Conditions

- 6. Moisture and lack of maintenance have caused cracks in plaster and peeling paint.
- 7. Moisture damage, on the north wall coming from the balcony, has caused discoloration on the wall, and separation of the ceiling/flooring.
- 8. The floor is beginning to deflect around the column, possibly due to improper support around the column that supports the second floor balcony.
- 9. Cracks in plaster below the window sill may be caused by the expanding and contracting of the wood.
- 10. The plaster has detached completely, exposing the brick wall behind it.

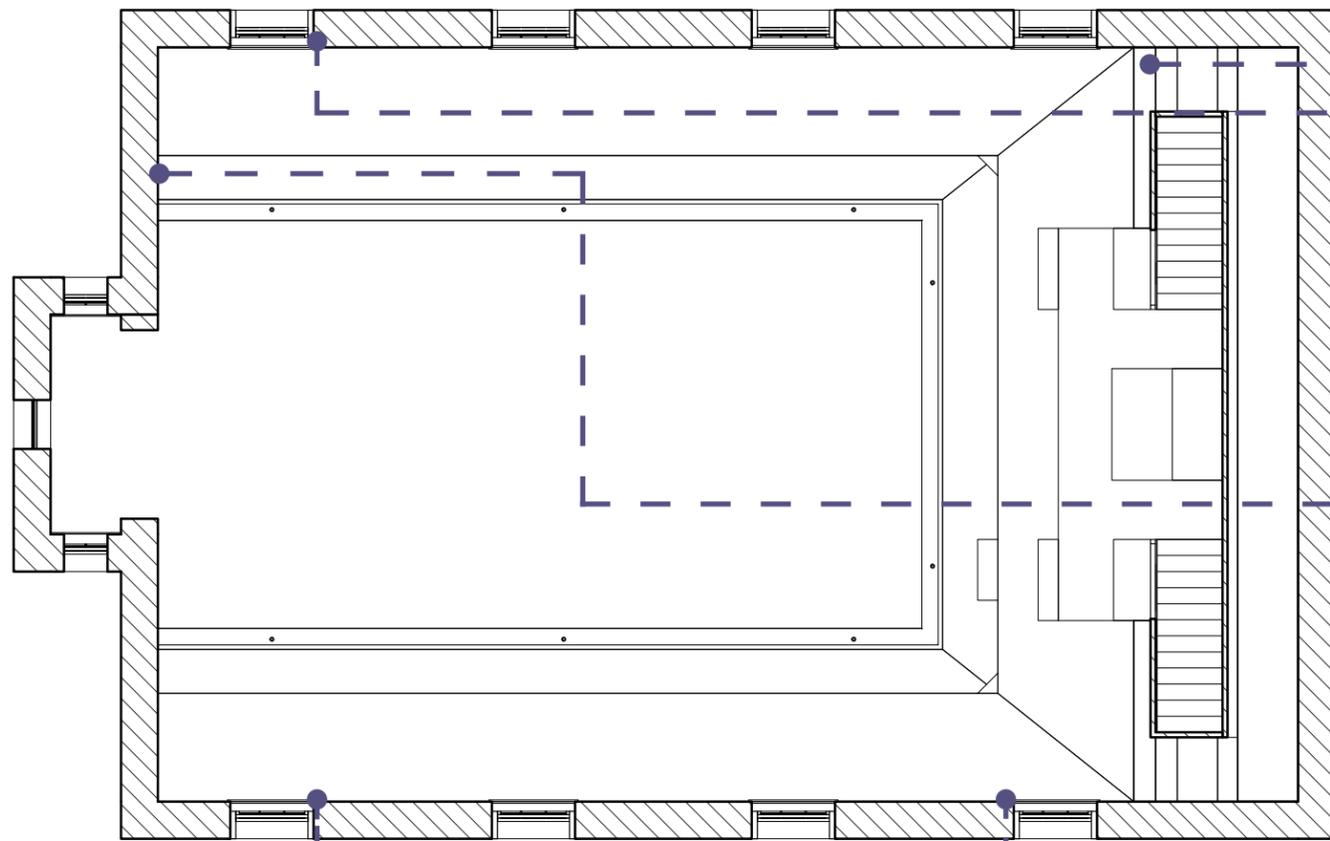
South and Balcony West and North Wall and Ceiling Conditions

- 11-13. Cracks in plaster have various causes: lack of maintenance, the building settling, and additional weight on non-load bearing walls, causing stress on the material. In most cases, this has exposed the brick substructure.
- 14. The cracks in the plaster were caused by structural issues that have caused the keystone piece above the window to fail.
- 15. Excessive weight on the floor/ceiling has caused the plaster to detach completely.

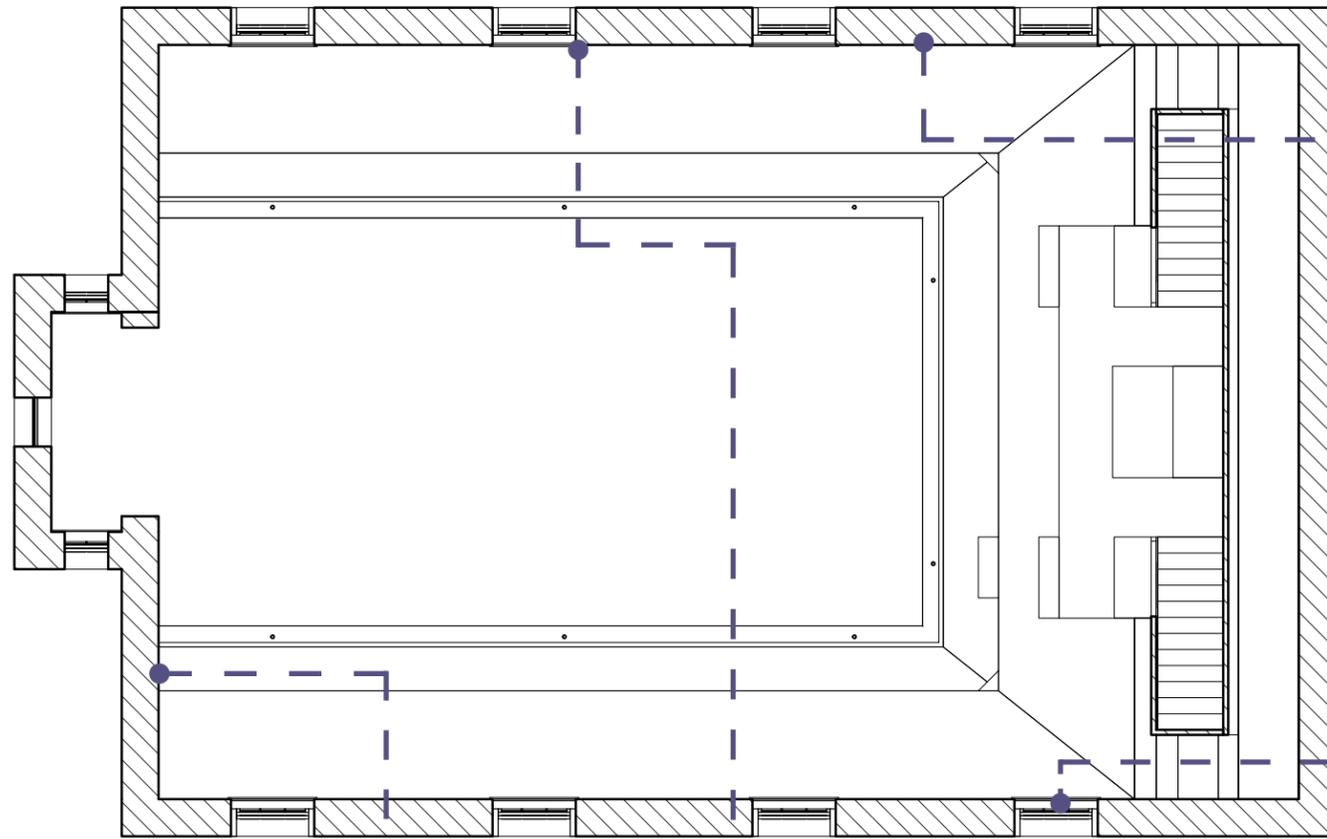
West and North Balcony Wall Conditions

- 16. Cracks in plaster have caused it to separate from the brick.
- 17. Spalling bricks and deteriorated mortar joints caused by lack of maintenance, and/or additional weight on a non-load bearing wall.
- 18. Cracks in plaster caused by the building settling or additional weight on a non-load bearing wall.
- 19. Plaster repairs have caused water to infiltrate through the joints, causing discoloration on the wall beneath it.
- 20. Water infiltration from the ceiling, from earlier roof damage (now repaired), has caused discoloration on the wall.
